CHEMICAL AND METALLURGICAL ANALYSIS OF PROPELLANT STORAGE VESSELS

FINAL REPORT - MARCH 1978 - OCTOBER 1978

BELL AEROSPACE TEXTRON DIVISION OF TEXTRON, INC. P. O. BOX ONE BUFFALO, NEW YORK 14240

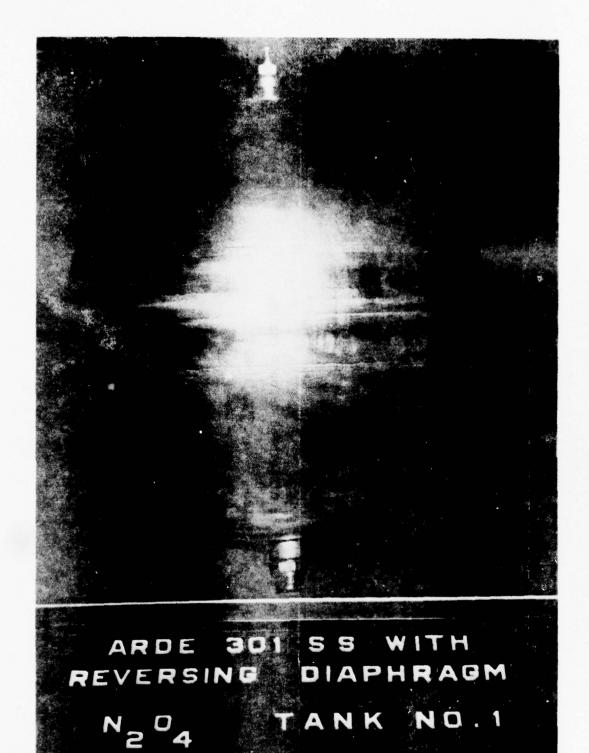
FIGURE 1. TANK NO. 1, AN ARDE CRYOSTRETCHED SPHERE WITH RING STIFFENED DIAPHRAGM. DARK SPOT APPEARS TO BE ARC STRIKE BUT MAY BE LOCAL CORROSION EFFECT.

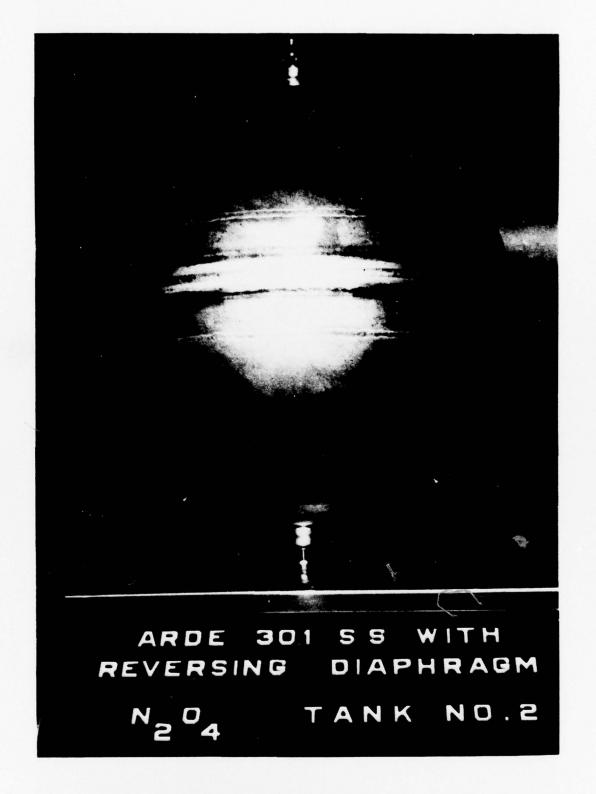
FIGURE 2. TANK NO. 2, AN ARDE CRYOSTRETCHED SPHERE WITH RING STIFFENED DIAPHRAGM. ALL FOUR OF THESE SPHERES SHOW STAINS (AT ARROWS) FROM THE SUPPORT THEY WERE SITTING IN.

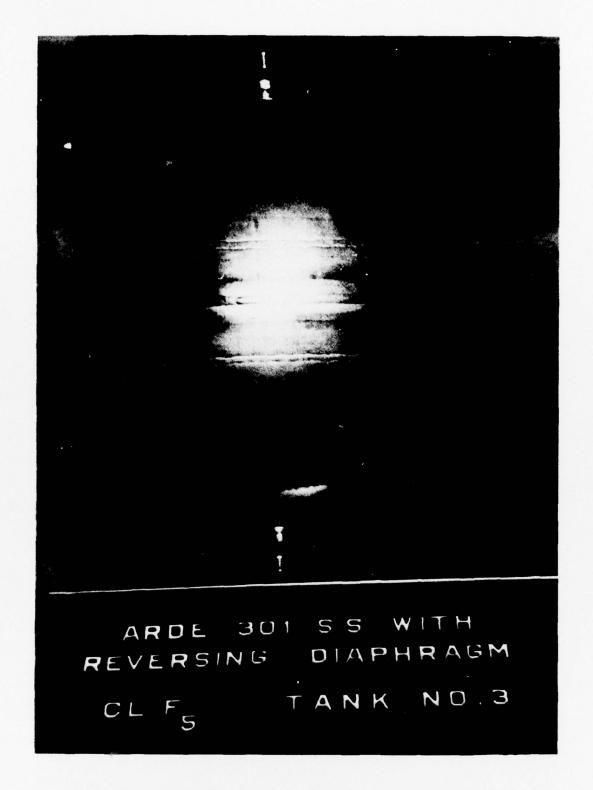
FIGURE 3. TANK NO. 3, AN ARDE CRYOSTRETCHED SPHERE WITH RING STIFFENED DIAPHRAGM.

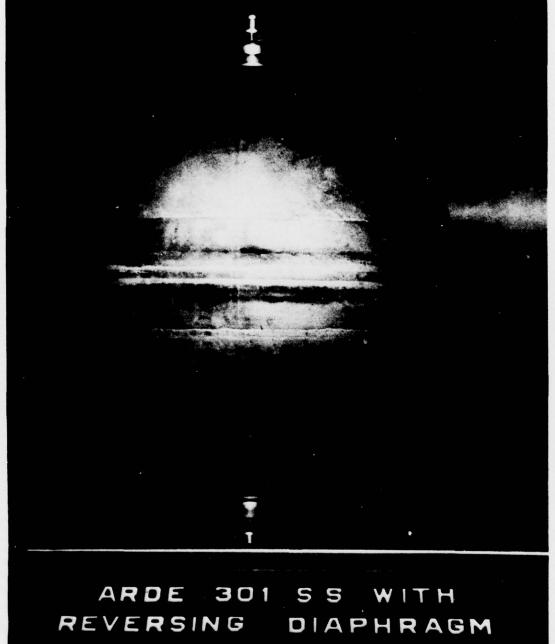
CL F₅ TANK NO.4

TANK NO. 4, AN ARDE CRYOSTRETCHED SPHERE WITH RING STIFFENED DIAPHRAGM SHOWING NO CORROSION OTHER THAN FIGURE 4. VER. MINOR PITTING AND STAINING.

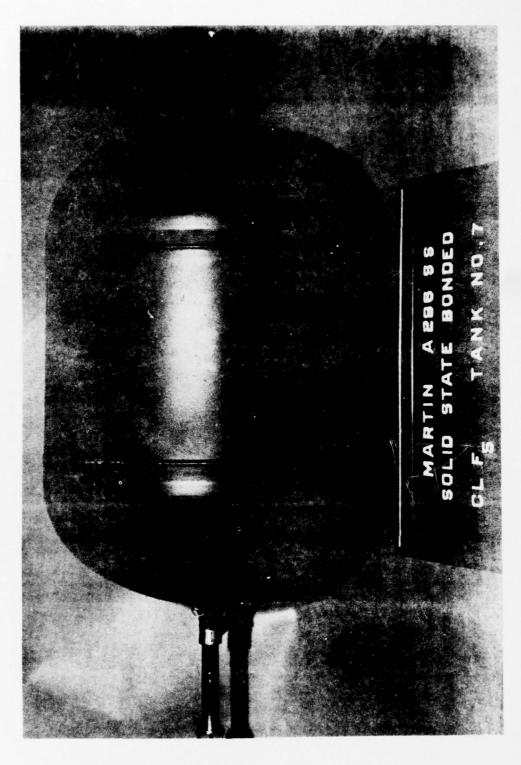
FIGURE 7. TANK NO. 7, SOLID STATE BONDED A-286, SHOWING NO AFFARENT CORROSION OR OTHER DAMAGE ON EXTERIOR.

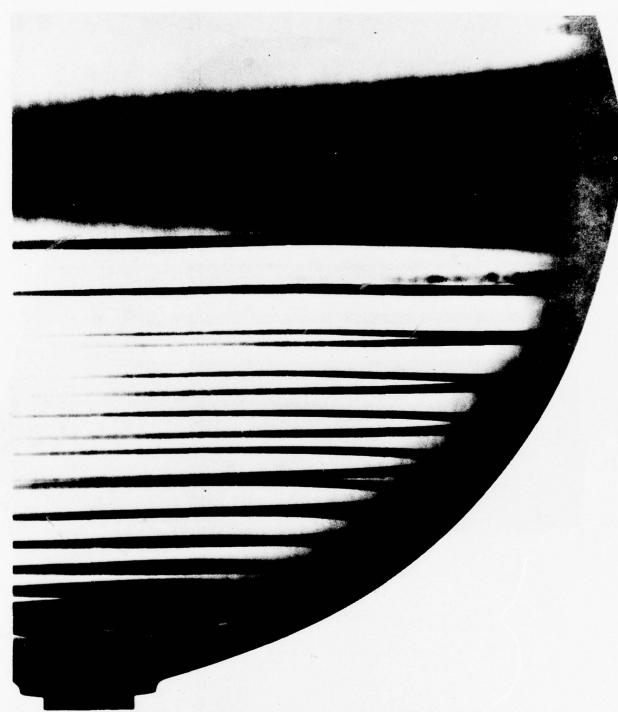
minor stains around the support cutout to be evidence of the orientation of the tanks during storage (see Figure 12 of Reference 5 for a view of these tanks during storage), it has been possible to orient the tanks in the proper vertical arrangement. This examination shows that two of the tanks, Nos. 1 and 4, were fully expelled with the diaphragms completely reversed. Tanks numbered 2 and 3 have diaphragms that were only partially expelled and evidently were drained without complete reversing of the diaphragm. This only partial reversal of two of the diaphragms made it possible to perform an expulsion test on the diaphragm of at least one tank. This test and its results are discussed in a separate Section, V.B., on the functional test of the diaphragm.

FIGURE 10. CONTACT PRINT OF RADIOGRAPH OF TANK NO. 1, AN ARDE RING STIFFENED DIAPHRAGM TANK IN THE AS-RECEIVED CONDITION SHOWING COMPLETE EXPULSION.

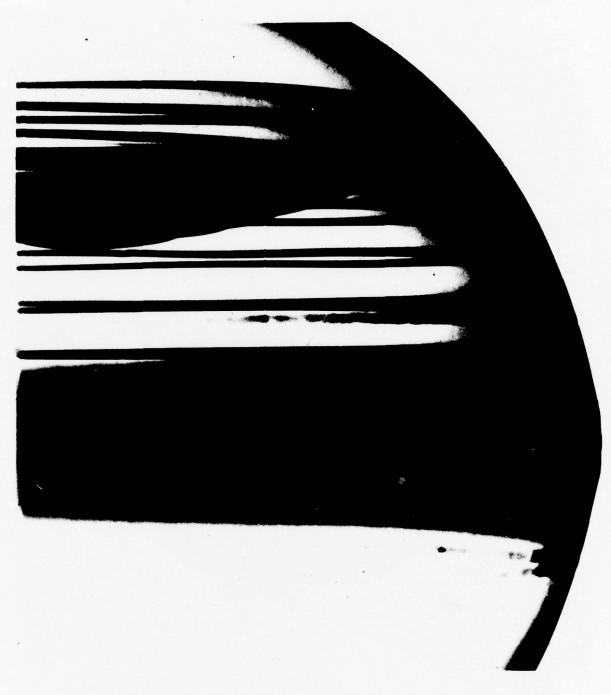
FIGURE 11. CONTACT PRINT OF RADIOGRAPH OF TANK NO. 2, AN ARDE RING STIFFENED DIAPHRAGM TANK IN THE AS-RECEIVED CONDITION SHOWING ONLY PARTIAL EXPULSION.

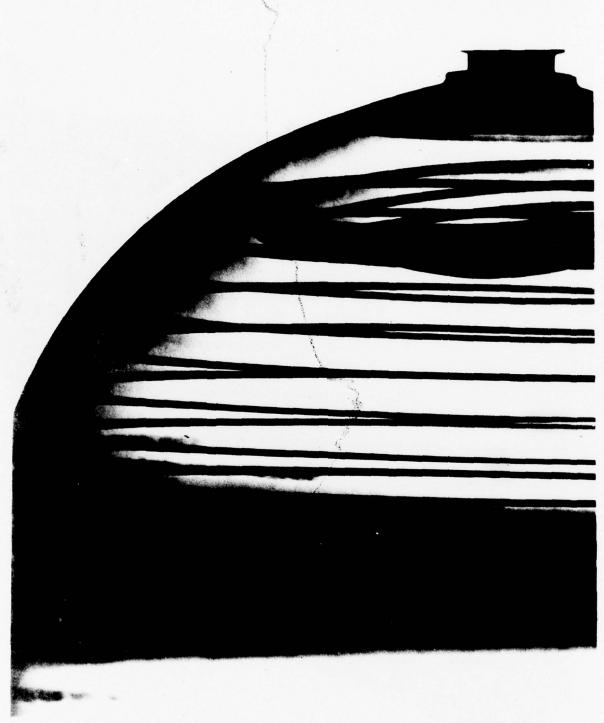
FIGURE 12. CONTACT PRINT OF RADIOGRAPH OF TANK NO. 3. AN ARDE RING STIFFENED DIAPHRAGM TANK, IN THE AS-RECEIVED CONDITION SHOWING ONLY PARTIAL EXPULSION.

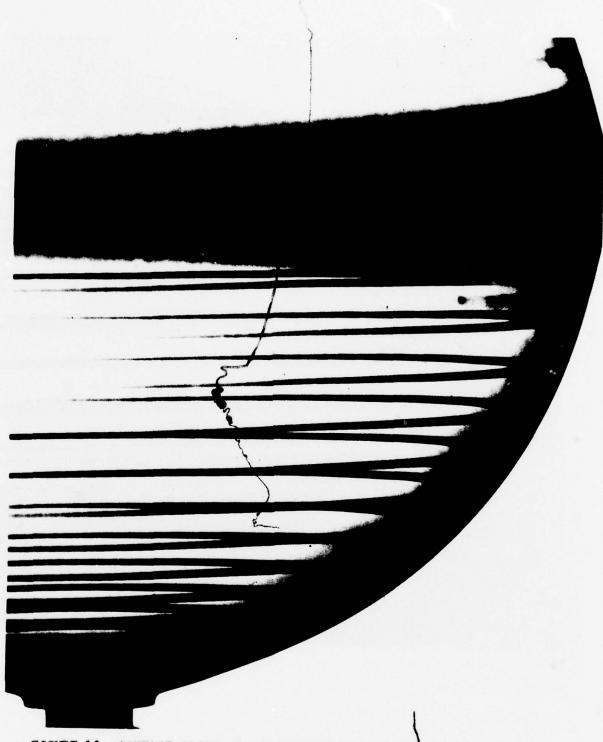
FIGURE 13. CONTACT PRINT OF RADIOGRAPH OF TANK NG. 4, AN ARDE RING STIFFENED DIAPHRAGM TANK, IN THE AS-RECEIVED CONDITION SHOWING COMPLETE EXPULSION.

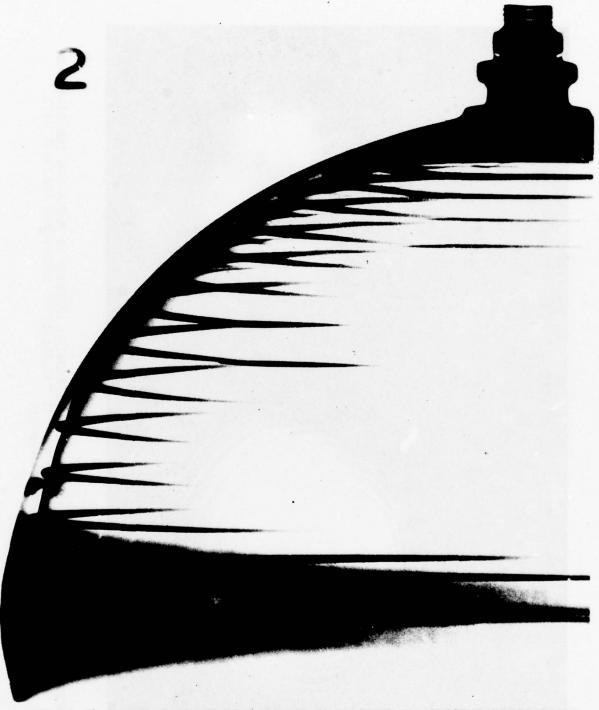
FIGURE 14. CONTACT PRINT OF RADIOGRAPH OF TANK NO. 2 AFTER PRESSURIZED LEAK TEST, SHOWING THAT DIAPHRAGM HAD RETURNED TO ITS ORIGINAL POSITION. DIAPHRAGM LEAK WAS DETECTED IN THIS TEST.

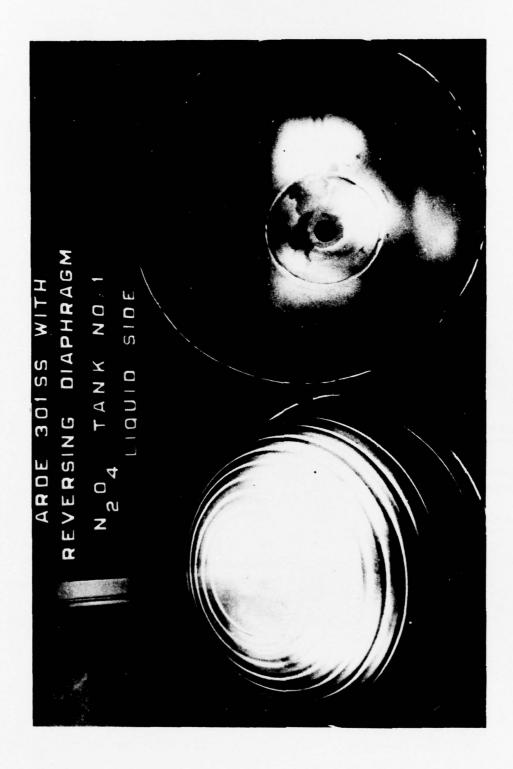
FIGURE 15. LIQUID SIDE OF ARDE TANK NO. 1 SHOWING INTERIOR OF SHELL AND THE DIAPHRAGM AFTER EXPULSION. STAINING IS THE RESULT OF INCOMPLETE DRAINAGE WITH PROPELLANT HAVING EVAPORATED.

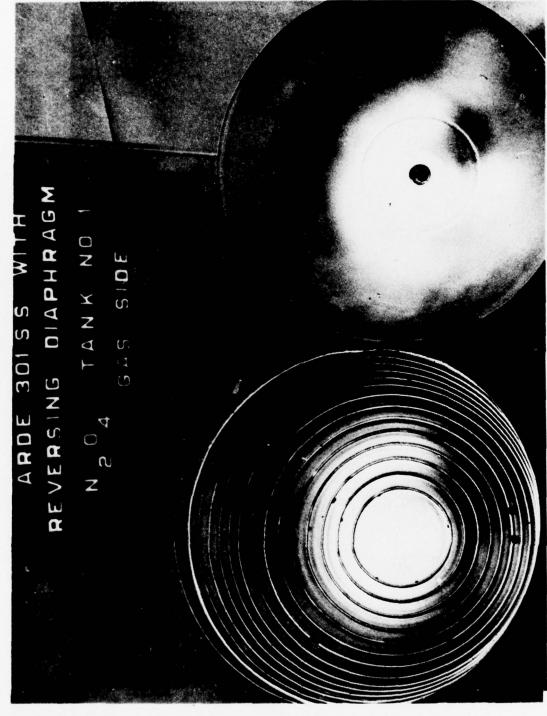
FIGURE 16. GAS SIDE OF ARDE TANK NO. 1 SHOWING INTERIOR SURFACE OF SHELL AND THE DIAPHRAGM AFTER EXPULSION.

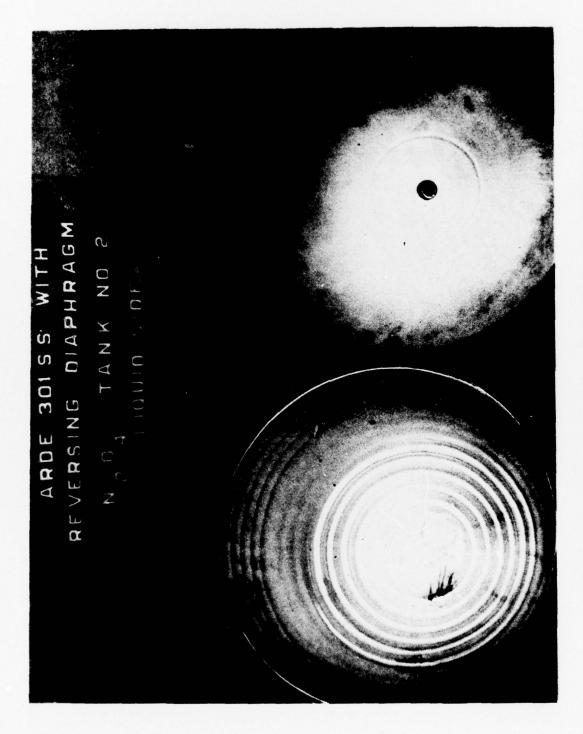
FIGURE 17. LIQUID SIDE OF ARDE TANK NO. 2. THIS DIAPHRAGM CONTAINS PINHOLE LEAKS IN THE UPPER DEFORMED SECTION OF THE DOME.

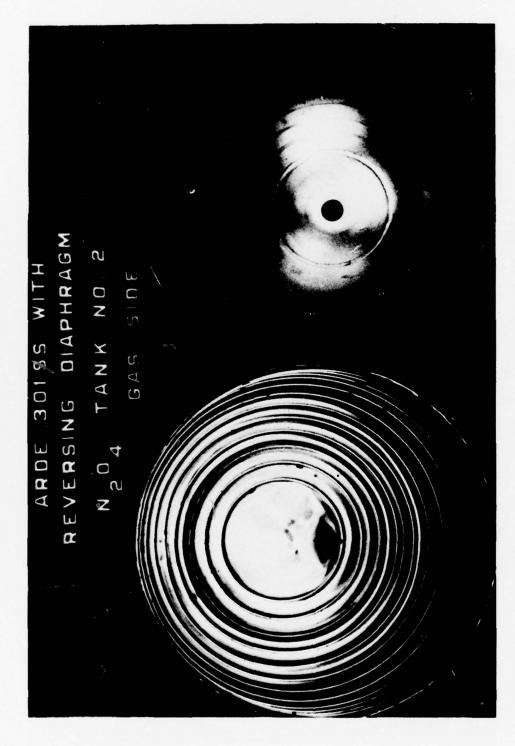
GAS SIDE OF ARDE TANK NO. 2. STAINS EXIST ON THE SHELL SURFACE AND THE WRINKLING/BUCKLING OF THE DOME IS VISIBLE. THE PINHOLE LEAKS NOT VISIBLE ARE CLOSE TO THE CENTER TOP SURFACE OF THE DIAPHRAGM. FIGURE 18.

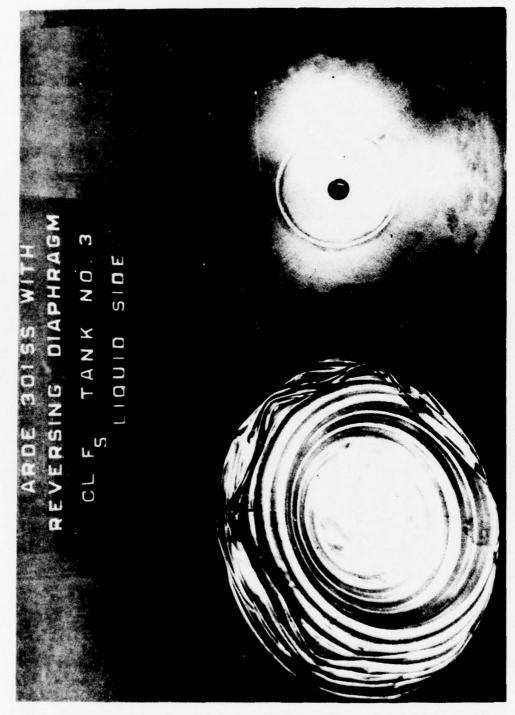
LIQUID SIDE OF ARDE TANK NO. 3. THE CONDITION OF THE DIAPHRAGM IS A DIRECT RESULT OF AN ATTEMPT TO REVERSE THE DIAPHRAGM AFTER COMPLETION OF AN EXPULSION TEST. LEAK OCCURRED AT SHARP BUCKLE (ARROW). FIGURE 19.

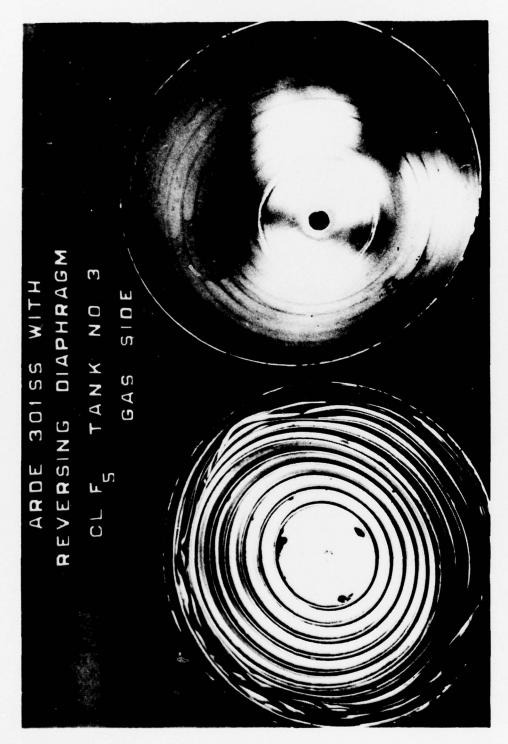
GAS SIDE OF ARDE TANK NO. 3. BUCKLING OF THE DIAPHRAGM IS QUITE EVIDENT IN THIS VIEW. THE STAINS IN THE SHELL ARE FROM THE EXPULSION TEST AND ARE NOT ATTRIBUTABLE TO CORROSION. FIGURE 20.

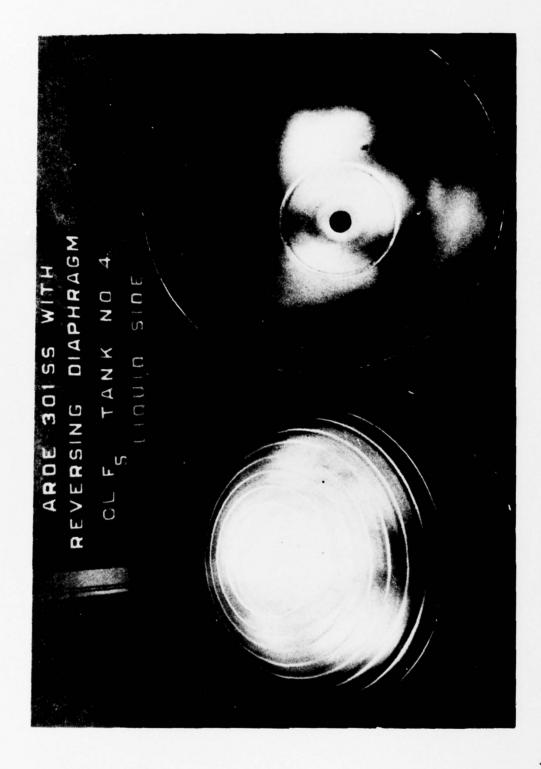
LIQUID SIDE OF ARDE TANK NO. 4. THIS TANK WAS RECEIVED IN THE FULLY EXPELLED CONDITION. SURFACES OF SHELL AND DIAPHRAGM WERE FOUND CLEAN AND FREE OF CORROSION FROM STORAGE. FIGURE 21.

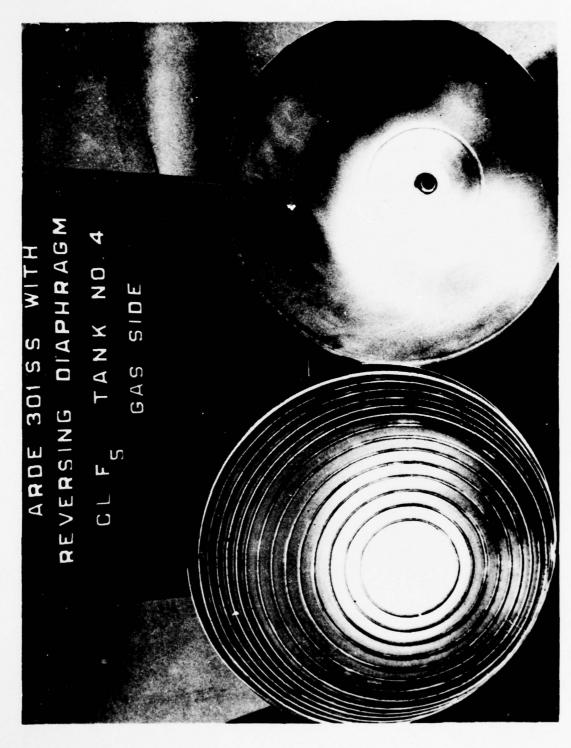
NO EVIDENCE OF CORROSION OR STAINING WAS FOUND. FIGURE 22. GAS SIDE OF ARDE TANK NO. 4.

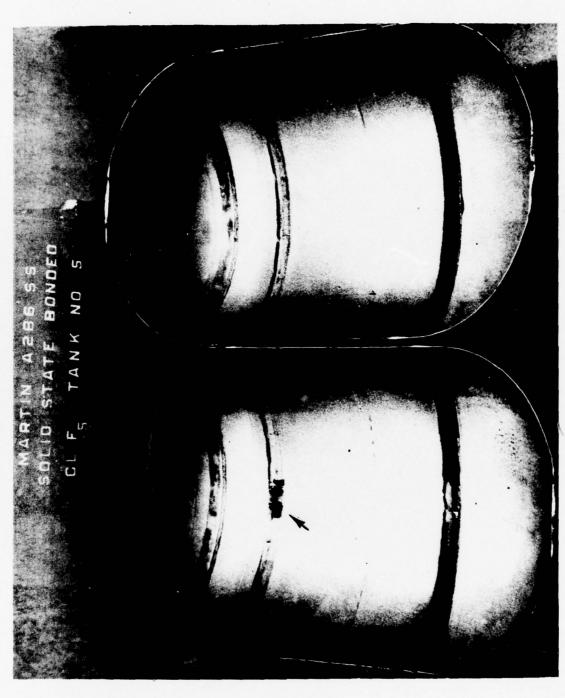
FIGURE 23. INTERIOR SURFACES OF TANK NO. 5. OVERALL CONDITION OF SURFACE APPEARS TO BE UNAFFECTED BY STORAGE. LOCALIZED AREAS HAVE BEEN MARKED WITH ARROWS WHERE A MORE DETAIL EXAMINATION OF THE SURFACE IS REQUIRED TO ESTABLISH IF CORROSION OCCURRED.

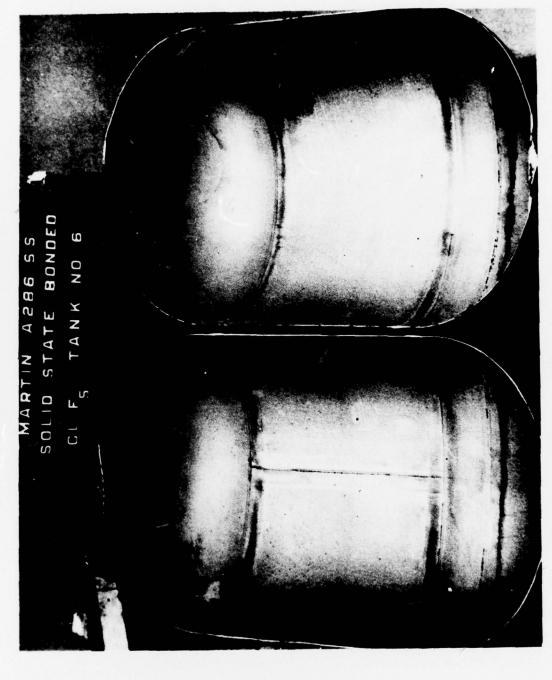
INTERIOR SURFACES OF TANK NO. 6. GENERAL SURFACE CONDITION WAS FOUND TO BE FREE OF STAINS, HOWEVER, SOME PITTING IS PRESENT AROUND PERIPHERY OF UPPER BOSS (RIGHTHAND VIEW OF SHELL), AN ARROW HAS BEEN USED TO SHOW THE AREA OF CONCERN. THIS REGION WILL BE INVESTIGATED IN GREATER DEPTH. FIGURE 24.

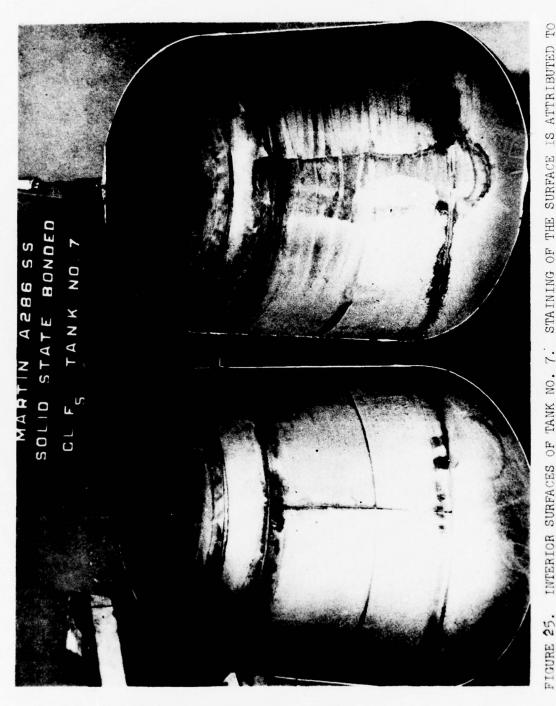
INTERIOR SURFACES OF TANK NO. 7. STAINING OF THE SURFACE IS ATTRIBUTED TO INCOMPLETE REMOVAL OF ALL PROPELLANT. AFTER UNLOADING TANK LAID ON ITS SIDE AND EVAPORATION OF CL F, TOOK PLACE, CAUSING STAINS AND CORROSION OF THE INTERIOR SURFACE. REACTION OF PROPELLANT WITH SURFACE NOT ATTRIBUTABLE TO STORAGE.

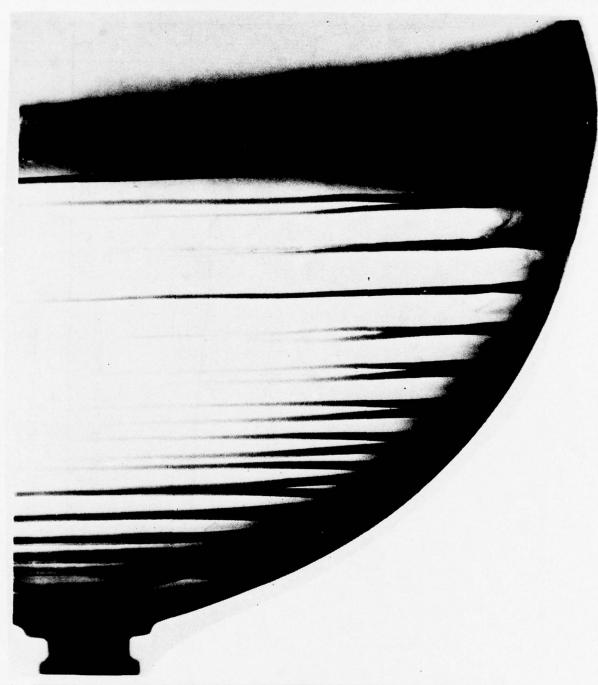
FIGURE 27. CONTACT PRINT OF RADIOGRAPH OF TANK NO. 3 AFTER COMPLETE EXPULSION AT BAT. WRINKLING AND BUCKLING OF DIAPHRAGM BETWEEN RINGS IS SEEN IN UPPER RIGHT SIDE.

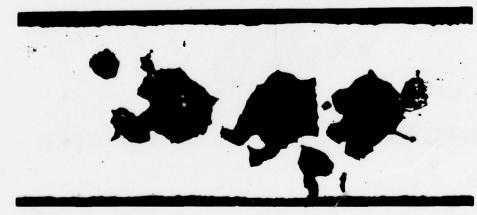
c) Cross section 0.002 inch beyond view (b), where first surface connection is seen.

FIGURE 34. DETAIL SURFACE VIEW AND INITIAL SECTIONS THROUGH ONE LEAK PATH IN DIAPHRAGM FROM TANK NO. 2.

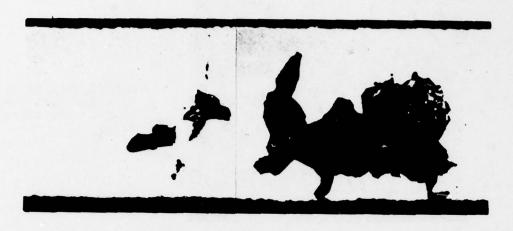
a) Section 0.0035 inch beyond initial site of corrosion. Total width of internal corrosion at this point is 0.021 inch.

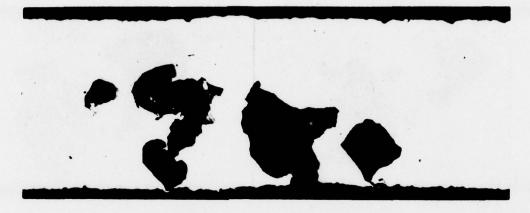
FIGURE 36. CROSS SECTIONS THROUGH LEAKING DEFECT IN AREA OF SECOND PIT VISIBLE IN VIEW (A) OF FIGURE 34.

a) Section 0.007 inch beyond start of second pit, view (a) of Figure 36, and 0.025 inch beyond initial corrosion observation.

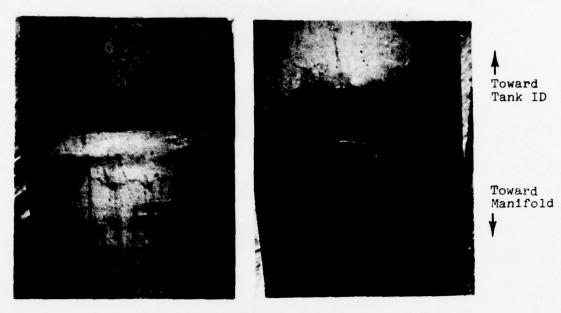
a) Tube at bond region where boss fitting is recessed, requiring tube to expand. Tear and corrosion/staining occurred at maximum expansion region.

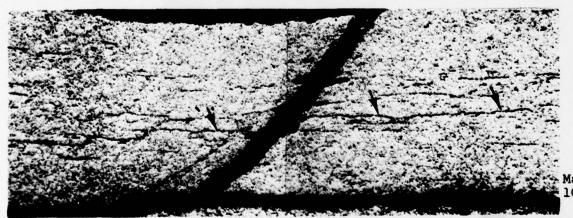
b) Detail view of split showing lack of any corrosion. Transverse fissures are at inclusions.

c) Etched view showing strain effects at arrows along inclusion streaks.

FIGURE 50. CROSS SECTION THROUGH TORN UPPER TUBE ILLUSTRATING THE 45° SHEAK, MECHANICAL FRACTURE APPEARANCE, TANK NO. 5.

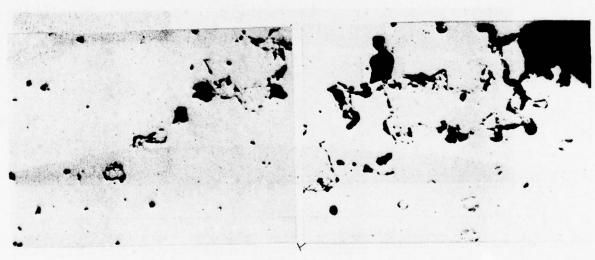
b) Detail views showing corrosive attack concentrated along intermetallic or inclusion particles.

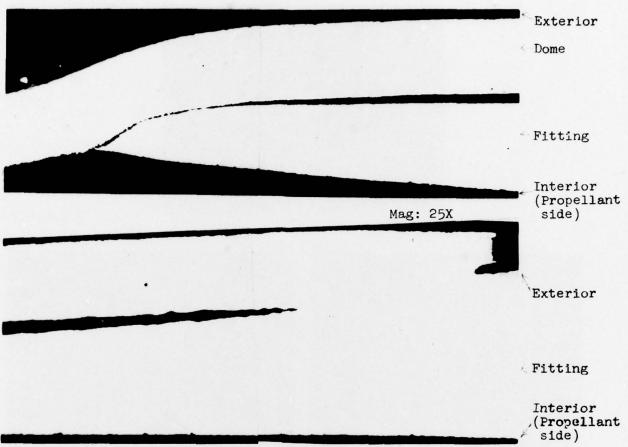
a) Section illustrating extensive cavity along bond, connected to interior, but sealed from exterior.

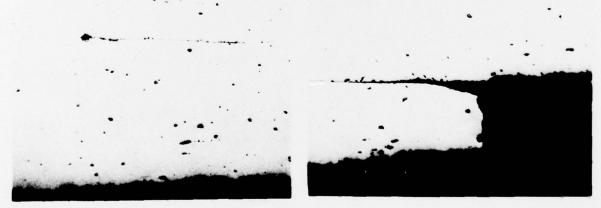
c) Section views showing slight attack in bond and along surface.

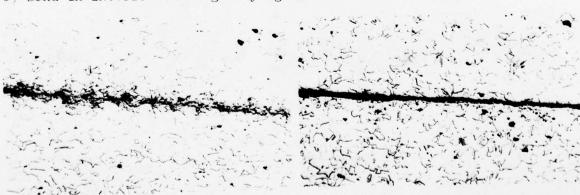
d) Bond when approaching ID showing tailoff of wave.

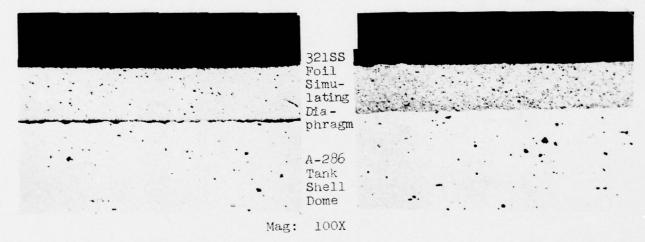
- b) Section near foil end of explosive joint showing essentially no bonding.
- c) Section near curled end of foil showing good bond to shell but none of the "waves" associated with normal bonds.

FIGURE 71. VIEWS OF BOND PRODUCED BETWEEN SIMULATED DIAPHRAGM STUB AND TANK SHELL IN A-286 TANK NO. 5.
